December 31, 2025

Subject: 2025 Annual Geologic Observations of Existing Rockfall Mitigation Measures,
St. Francis of Assisi Roman Catholic Church, 2746 Fifth Street, Castle Rock,
Colorado.

Project Number 24-2-141

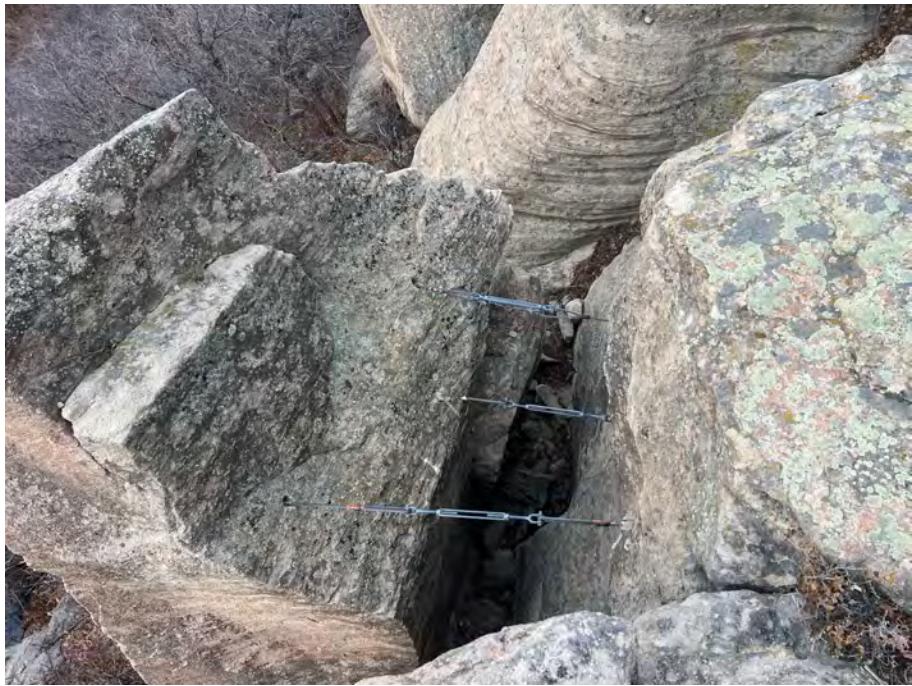
Area 1 is the southeast-most area observed and is located approximately 140 feet south of the southeast corner of the main building at the site. This area is situated just east of the large block that detached in 1981, with mitigation measures consisting of cable-lashing to secure a large, partially detached pillar. A secondary block just east of the cable-lashed block was measured by K&A in 2024. Observation and measurement of this secondary block just east of the cable-lashed block showed an approximate movement of about 0.5-inches since the previous observation by K&A in 2024. As movement was observed, observation should continue, with additional measurement methods recommended in subsequent annual observations. This unrestrained, detached block was measured approximately 2 feet west of the east edge of the block, and observation and measurement of this block should continue to occur. The unrestrained block has a vertical joint trending east to west that is a continuation of the joint that separated the adjacent cable-lashed block. Erosion at the base of the block and freeze-thaw cycles create the potential for continued movement. K&A should be notified if any noticeable movement occurs. The cables and cable seating of the cable-lashed block did not show any signs of deterioration since the previous observation by K&A.

Area 1- Cable-lashed Pillar

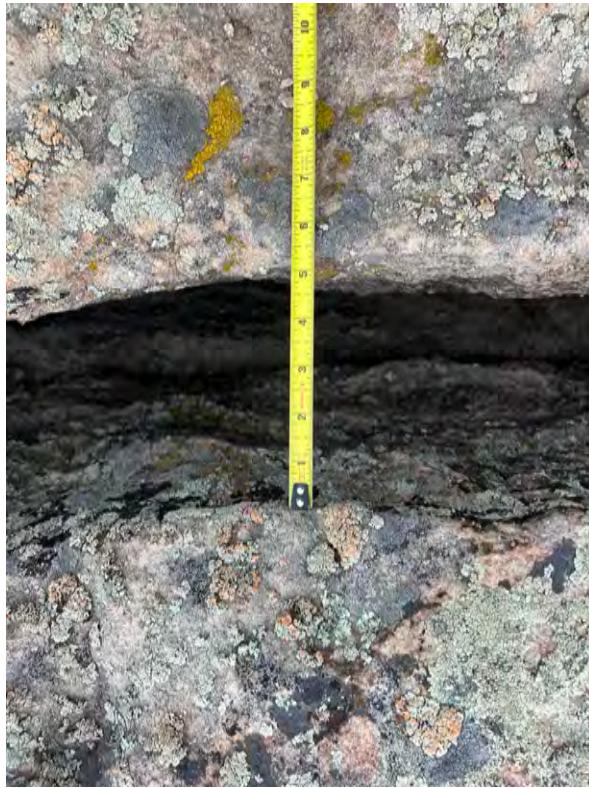
There were no obvious signs of block movement observed in Area 2, Area 3 East, or Area 3 West compared to the previous observations made by K&A in 2024. The detached block east of the cable-lashed block in Area 1 had measured movement compared to the observations of 2024. Continuing observation and measurement of the detached block should occur, and additional measurement methods are recommended for subsequent observations. If movement continues, mitigation methods will need to be implemented. Erosion at the base of the cliff at the catchment of Area 2 was observed to increase from the year prior, and smaller, cobble-sized material, determined to originate from the base of the cliff, was noted to have accumulated within the catchment. The catchment should be cleared and maintained as material accumulates and should be observed regularly. It was noted that delamination appears to be continuing at the extent of the shotcrete in Area 2. This delamination does not appear to be occurring in an area critical to the overall stability of the stabilized block. This delamination and erosion is expected to continue and should be observed annually. The baseline references made within Area 1 and Area 3 West should have measurements taken as part of the annual observation. The next annual observation should occur in late 2026. Any observed movement outside of the annual observations should be reported to Kumar & Associates, Inc. immediately upon occurrence for reevaluation.

Area 1- Secondary Boulder, Unrestrained, Baseline Reference

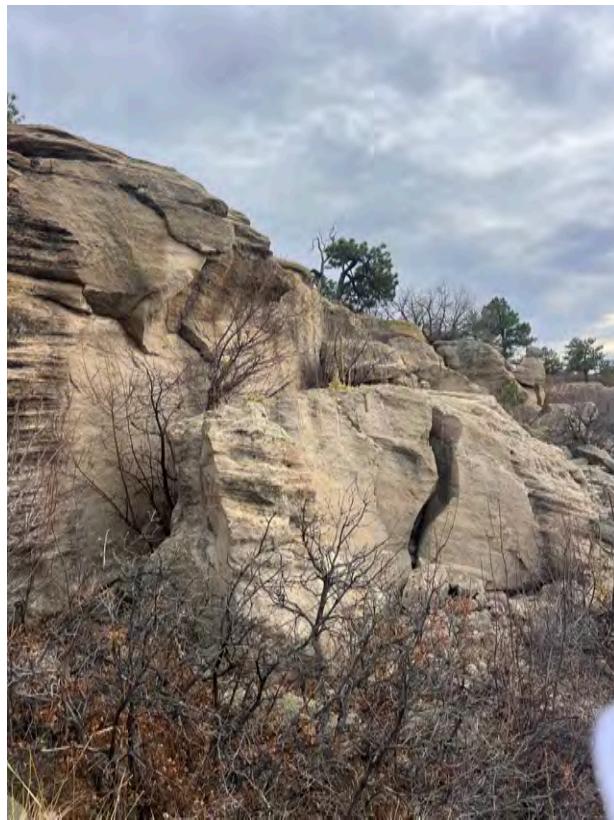
Area 2 is the center area observed and is situated approximately 80 feet south-southeast of the west end of the asphalt-paved fire lane located on the south side of the main building at the subject site. This area is located just west of the large block that detached in 1981. This area contains a catchment below an overhanging block. No movement of the overhanging block or adjacent blocks was observed since the previous observation by K&A. Several smaller cobble sized rocks were observed to have accumulated within the catchment. Erosion was observed to have progressed at the toe of the overhanging cliff, in addition to animal burrowing along the base of the cliff and soil slope beneath the toe of the cliff. Continuing increased erosion can reduce the stability of larger blocks supported by the soil being eroding and the progression of erosion should continue to be observed moving forward. The area of the 1981 detached block, between areas 1 and 2, was observed to show no signs of movement since the previous observation by K&A.

Area 2: From Catchment Looking East Toward 1981 Rockfall Area

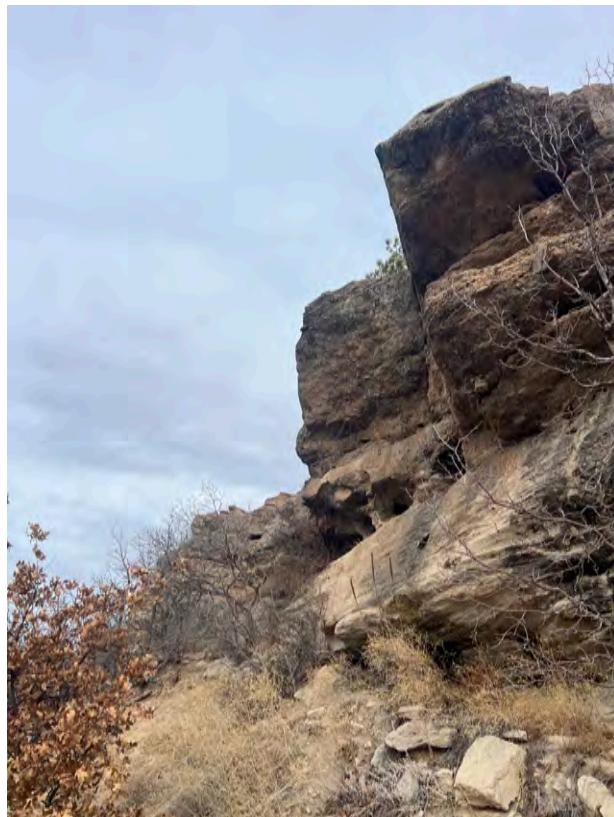
Area 2: From Catchment Looking North Toward Area 2

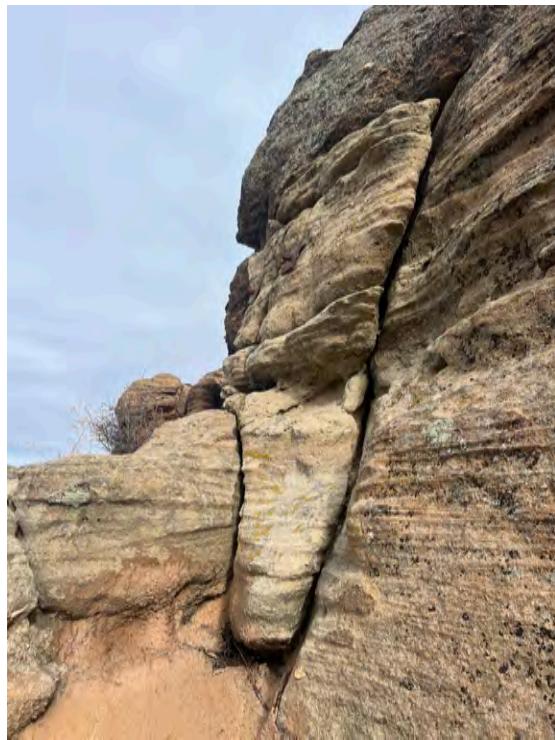
Area 3 East is located approximately 100 feet west-southwest of the south end of the west wing addition to the main building at the subject site. The rockfall mitigation in this area consists of shotcrete application and rock bolting. The rock bolted block did not show signs of movement since the previous observation by K&A. The K&A observations from 2024 showed that delamination is occurring on the outer extents of the shotcrete application, and that it was relatively easy to peel the shotcrete off in these areas. The current observation of the shotcrete showed that delamination is continuing on the outer extents of the shotcrete zone, increasing delamination from the prior observation. This is occurring on the outer edge of the application in an area not critical to stability, however, this delamination is expected to continue and should be observed annually to ensure the continual delamination/erosion of shotcrete will not reduce the stability of the blocks it is supporting.

Area 3 East- Rock Bolted Block and Shotcrete

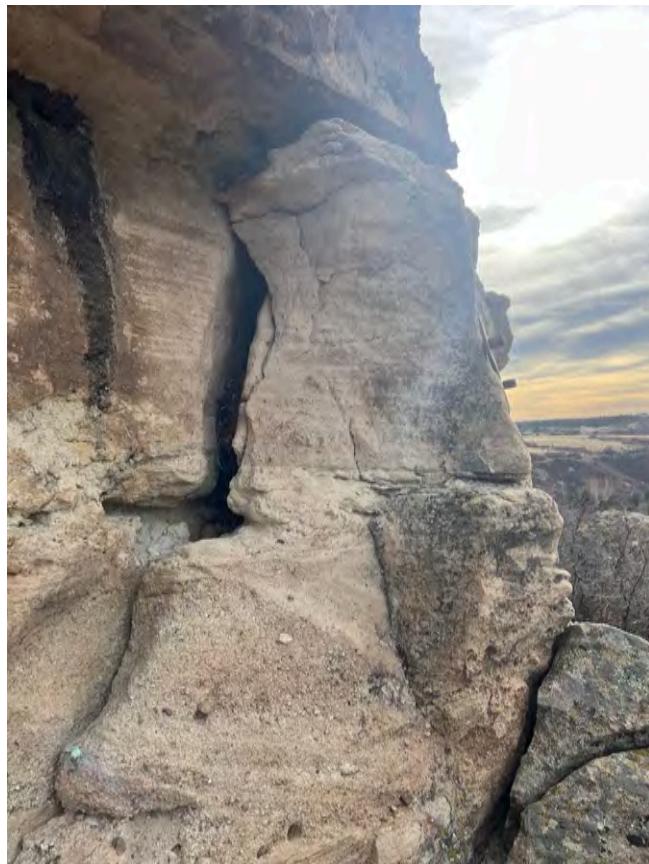
Area 3 East- Rock Bolted Block

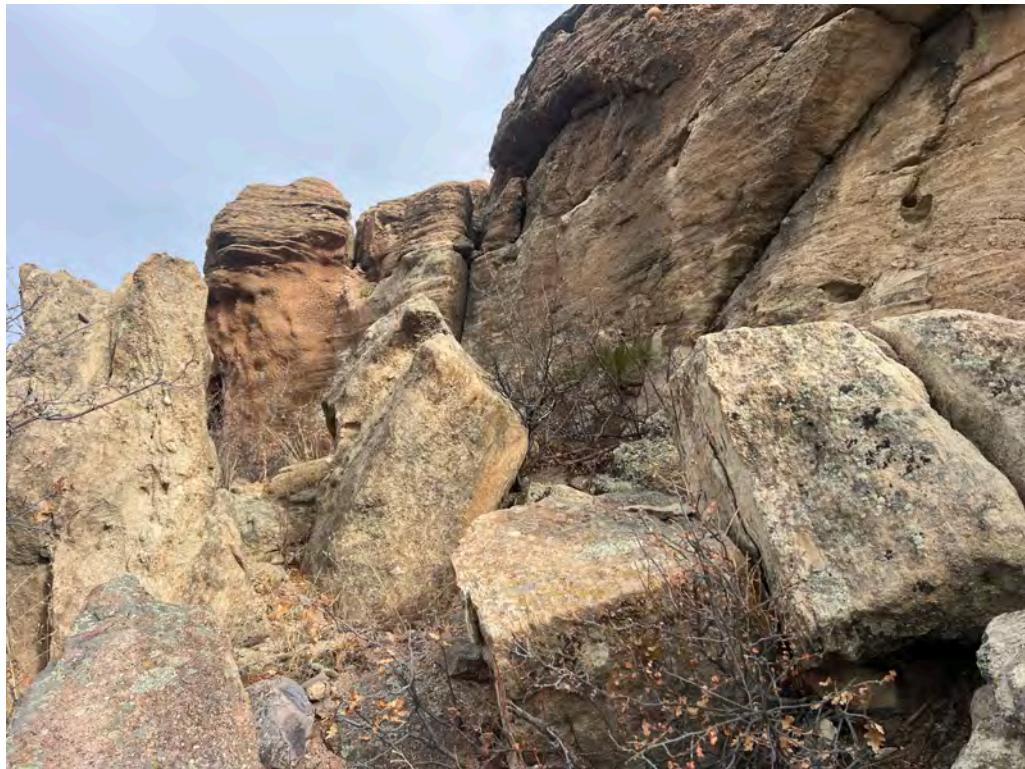
Area 3 West is the northwest-most location observed and is situated approximately 80 feet west of the center of the west wall of the main building at the subject site. Rockfall mitigation methods in the area include rock bolting and shotcrete application. It was noted that there are not any homes directly beneath the fallout zone of this area. The shotcrete application in this area is

Area 3 West: Shotcrete

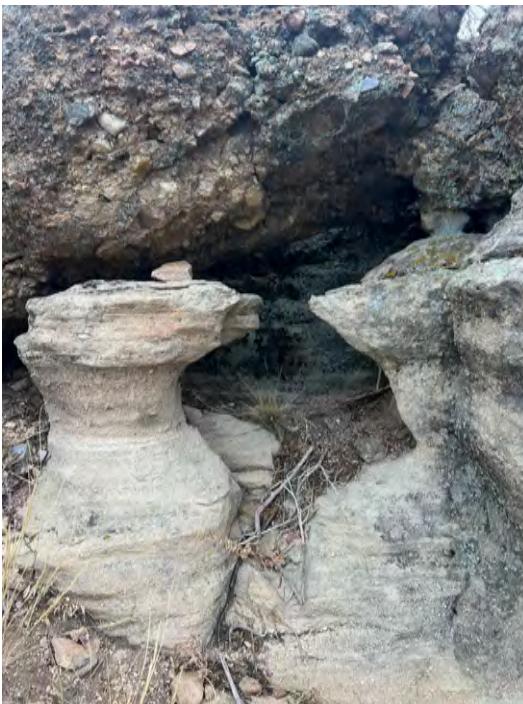
Area 3 West: Eroded Contact of Overhanging Block

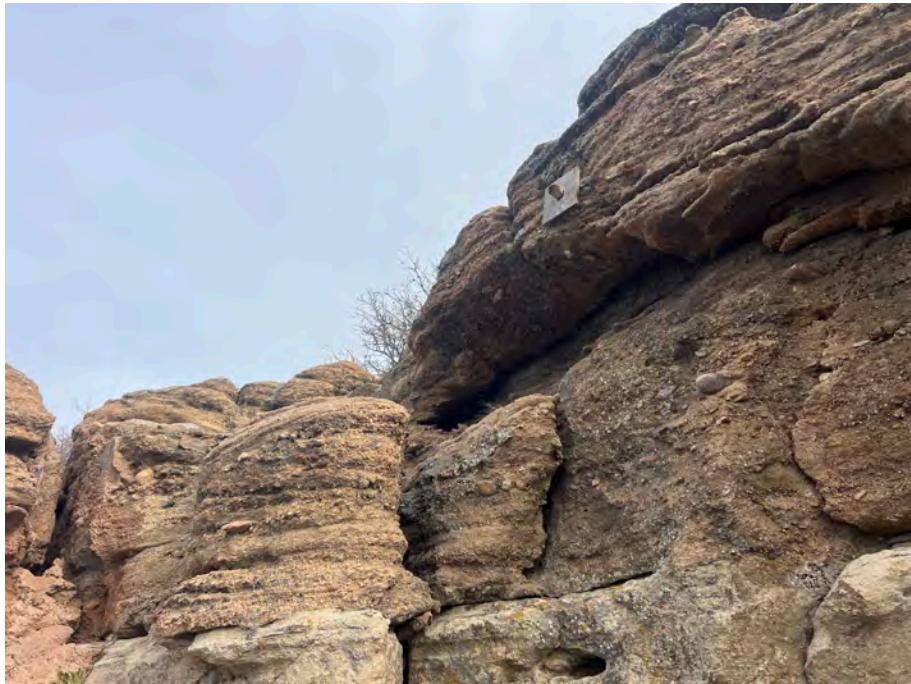
Area 3 West: Rock Bolted Block From Below

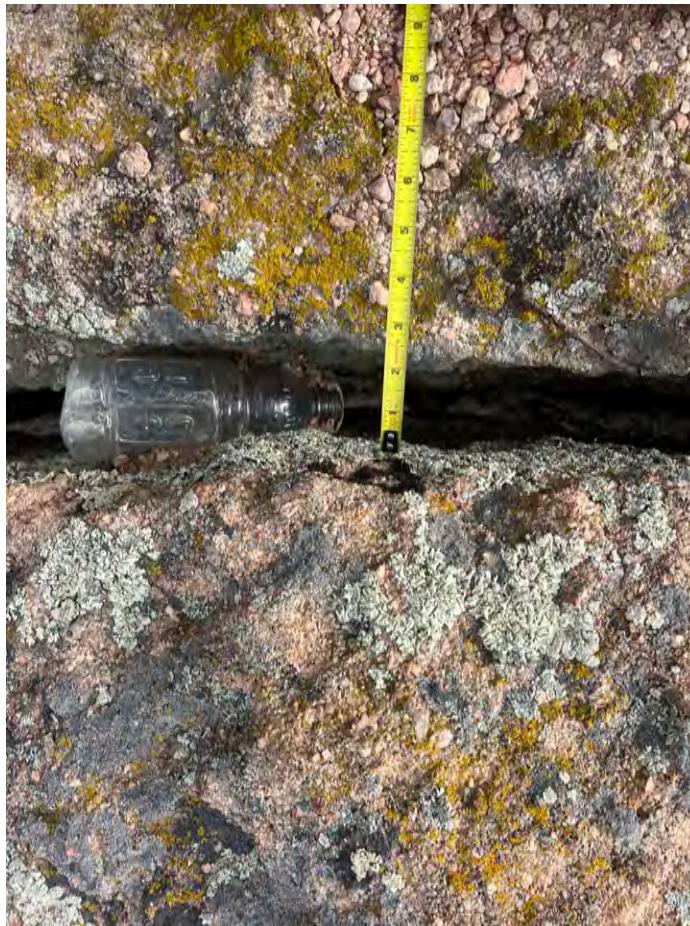
situated below an overhanging partially detached block. Multiple rock bolts are also applied to additional sections of overhanging partially detached blocks. At the northwest-most rock bolted block, a fracture was observed developing approximately 1 foot to the northwest of the rock bolt, in a position that would cause a portion of the block to fall should the fracture separate that portion of the block from the main mass of the rock bolted block. Measurement was taken of the detachment width of the northwest-most rock bolted block approximately 2 feet to the northwest of the rock bolt. No movement of this block was observed during the current K&A observation, however annual observation and measurement of this block should continue. Both the shotcrete and the rock bolted blocks did not show any signs of movement since the previous observation by others.

Area 3 West: Rock Bolted Block, Baseline Reference
